To: Mayor and Council
From: Paul McMunn, Director of Public Works and Utilities
Date: April 21, 2026,
Committee of the Whole Date: April 27, 2026
Title: Old Water Tower

**Smiths Falls—Multi-Legged Tank
Clean, Inspection and Report
May 17, 2022**

Town of Smiths Falls
Smiths Falls Multi-legged Tank
Clean, Inspection and Report / Leak Repairs
May 13, 2024

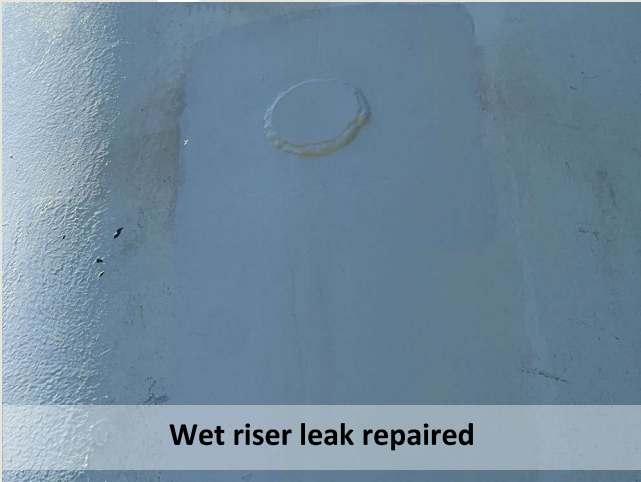
12

Wet riser leak repaired
