To: Mayor and Council
From: Paul McMunn, Director of Public Works and Utilities
Date: April 21, 2026,
Committee of the Whole Date: April 27, 2026
Title: Old Water Tower

**Smiths Falls—Multi-Legged Tank
Clean, Inspection and Report
May 17, 2022**

Town of Smiths Falls
Smiths Falls Multi-legged Tank
Clean, Inspection and Report / Leak Repairs
May 13, 2024

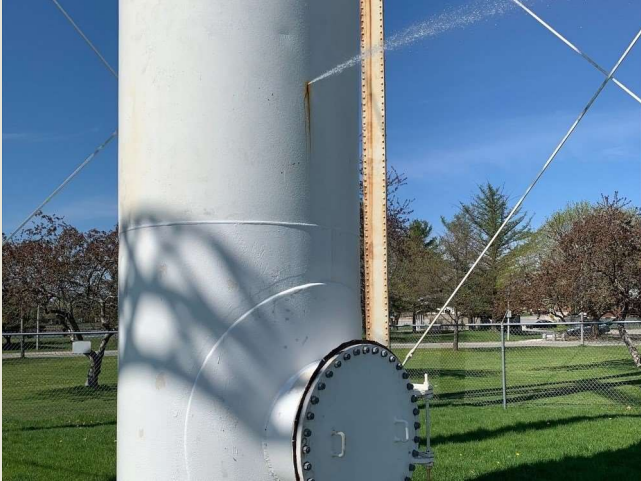
11

Repairs Made During Inspection	Photo No.	Photo No.
Riser leak repaired	10-13 -- --	-- -- --
Recommended Repairs		
<u>Siteworks</u>		<u>Accessories</u>
Extend overflow away from foundation	20 --	Replace all non-compliant ladders c/w tie-offs Design, fabricate and install roof handrail Design, fabricate and install wet riser guardrail
		27, 55, 76 59 79
<u>Security</u>		
Move antenna cables to tank leg	33-34 -- -- --	-- -- -- --
<u>Valve Chamber / Pit</u>		<u>Fall Arrest System</u>
	-- -- --	Install new fall arrest system on new ladders Install Transfer 'D' rings on new roof handrail
		-- -- --
<u>Support Leg Foundations & Anchorage</u>		
*See Separate Coatings and Linings Report	-- -- --	-- -- --
<u>Support Structure</u>		<u>Confined Space & Rescue System</u>
	-- -- -- --	Install rescue port base at catwalk ladder Install rescue port base at roof access hatch
		45 60
<u>Exterior Balcony (Catwalk)</u>		<u>Coating & Lining Condition</u>

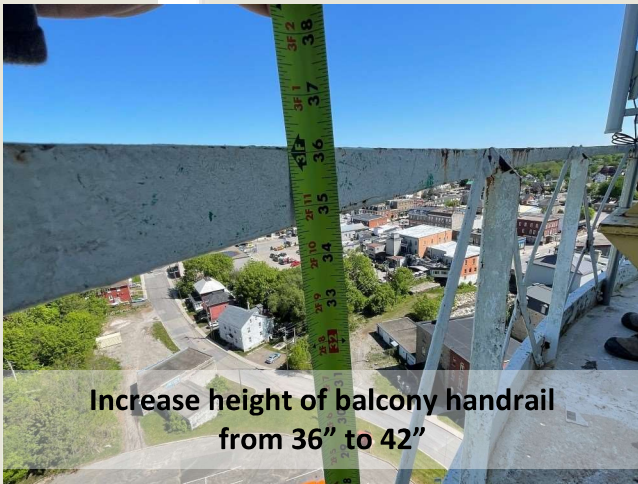
52

Increase height of balcony handrail from 36" to 42"

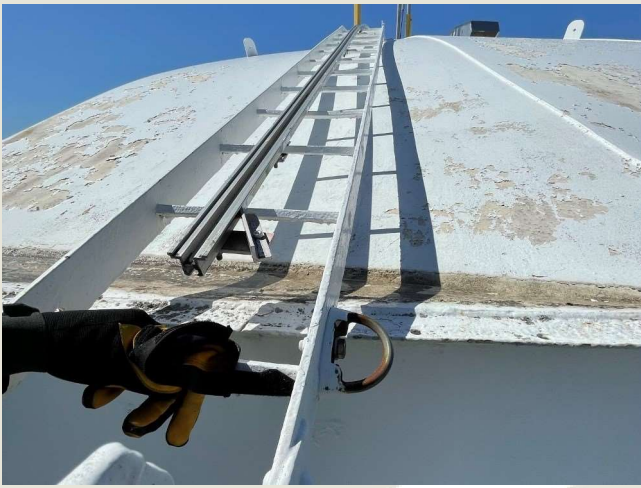
56

Fixed access ladders are non-compliant to current standards whereas the rung lengths (inside to inside of side rails) are 13". The minimum required rung length by current standards is 16". In addition, rung diameters are 5/8" dia. (code requirement is 3/4" dia. minimum) and the existing fall arrest system is over-coated in many areas and should be replaced as this prevents the fall arrest trolley from freely gliding along the track.

Supply and install new 16" wide galvanized ladder system & support brackets c/w new CSA approved fixed rail fall arrest system

- Remove and dispose of existing ladder system
- Supply and Install (S&I) new 16" wide galvanized ladder system & support brackets
- S&I new aluminum fixed rail fall arrest system compliant to current CSA Standards c/w end stops
- Remove and replace 'D' rings with S.S.

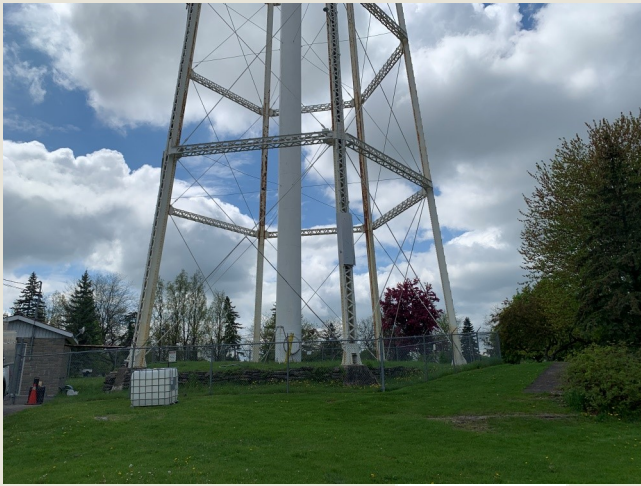
1

EXTERIOR VALVE PIT / BUILDING	Pit - Good	6-20
DRIVEWAY / WALKWAY	Grass - Good	1-4
OVERFLOW SPILLWAY	Fair - extend overflow away from foundation	20

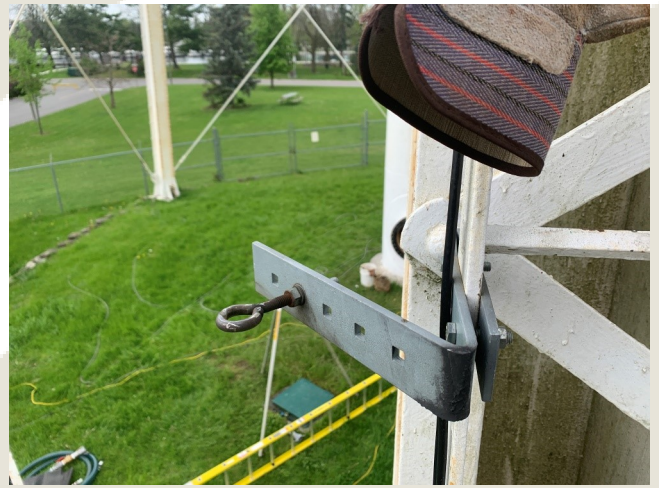
TRANSFER STATION 'D' RINGS			
LOCATION	YES / NO	CONDITION	
* AT VALVE PIT	N/A	--	--
* AT BOTTOM OF VERTICAL LADDER	Yes	Fair - Replace with S.S.	25
* AT TOP OF LADDER TO BALCONY	Yes	Fair - Replace with S.S.	53
* AT TOP OF LADDER TO ROOF	Yes	Poor - Replace with S.S.	72
* AT ROOF HATCH	Yes - Dismount post	Poor - Replace with S.S.	88-89
* AT CENTRE OF TANK ROOF	Same as above	--	--

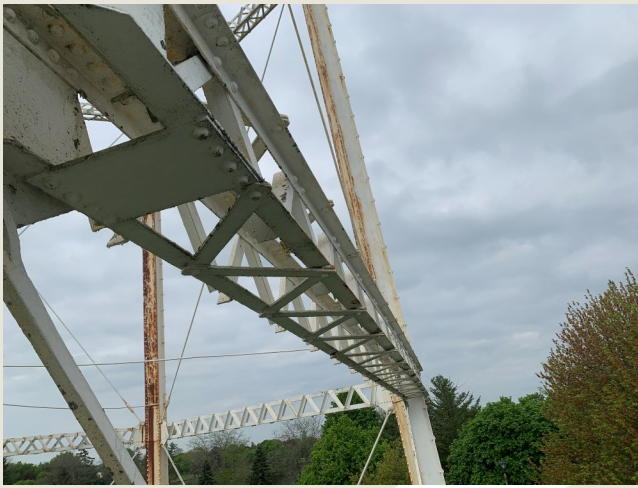
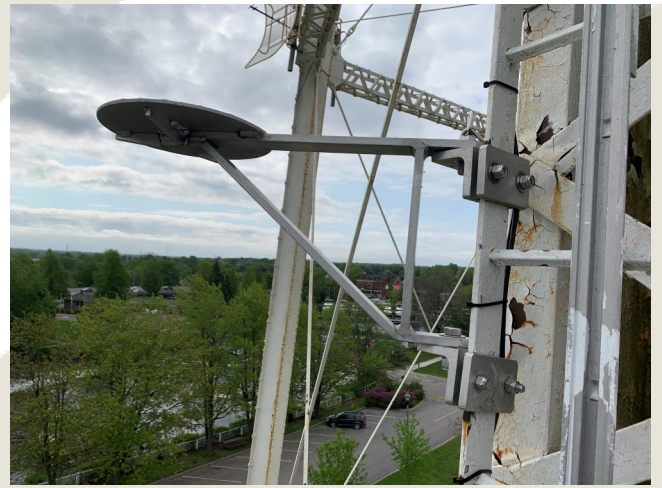
STRUCTURAL CONDITION OF WET RISER?	*Poor - Corroded internally /Guardrail recommended	122-124
STRUCTURAL CONDITION OF SUPPORT LEGS?	*Poor	35-36
STRUCTURAL CONDITION OF STRUTS AND COLUMNS?	*Poor	32-33
STRUCTURAL CONDITION EXTERIOR TANK SURFACES	*Fair	44-49
STRUCTURAL CONDITION INTERIOR TANK SURFACES	*Poor	92-107

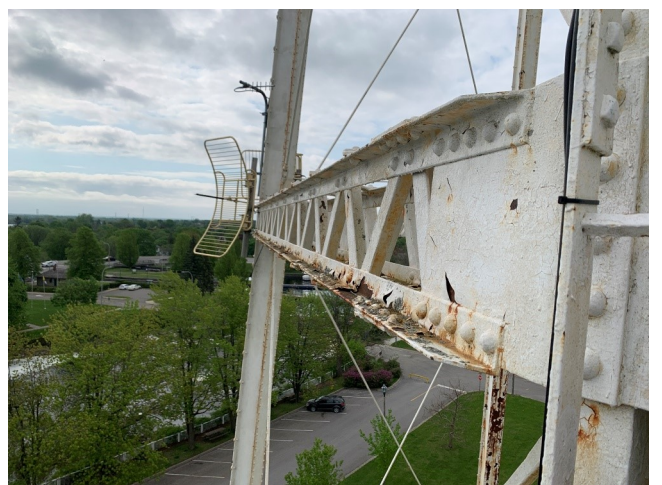
39

* Condition	Good	86-87
PAINT RAIL / ROOF COUPLINGS		None	--
ROOF HANDRAIL		None - Recommended	72, 78
WET RISER GUARDRAIL		None - Recommended	104
WET RISER ACCESS FROM GROUND		30" Bolted manway	109-111
TANK ACCESS FROM CATWALK		36" Bolted manway	58
OVERFLOW PIPE (3" dia.)		Fair - Extend away from foundation	22
CATHODIC PROTECTION		None	--
AIRCRAFT WARNING LIGHTS		None	--
ANTENNAE	* Anchorage / Mounting	Good	39,62,66,84
